MK 14 MOD 2 Corrective Action Status / Evaluation Results to Date 27 June 2012
Reference Task List from POA&M Scope/Mount/Precision/Function Issues w/ details:

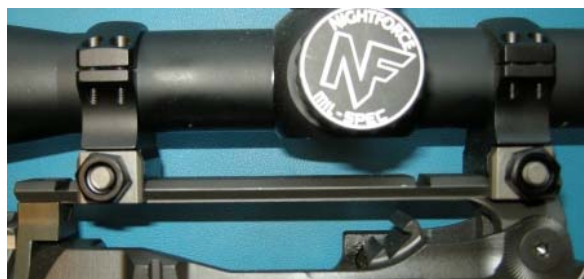
Crane Design Mount with Optic Installed

Results: Desired contact surfaces and clamp bar gaps were confirmed on 6 each MK 14 MOD 2 Rifles. Ring contacts confirmed are lower 45 degree angled surface on one side of rail, full top rail surface and lower 45 degree angled surface on opposite side of rail (contact with lower angled portion of movable jaw / clamp bar). Clamp Bar gap was good (approx. 0.015" min.) – plenty of clearance / movement range remaining when installed. Rail size is very consistent (0.001" total tolerance seen in samples). Ring recoil lug thickness was also measured as was rail recoil lug slot width – there were no potential interferences found. However, the forward slot of the rail does typically allow the forward attachment screw head to enter slightly into the slot area reducing its effective width to within as little as 0.002" of the ring lug width (this slot is not used for initial optic installation).

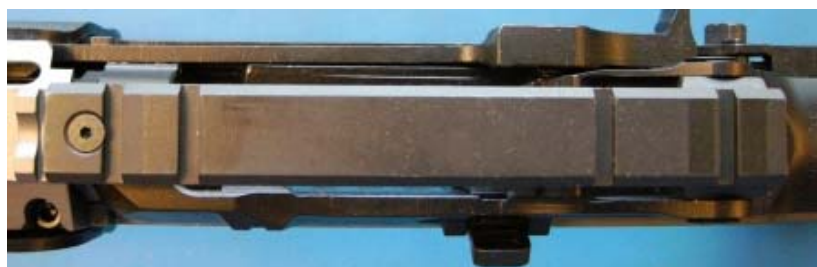
Top View of Crane Mount Rail

(note that top mount screw head can extend into front slot reducing its effective width)

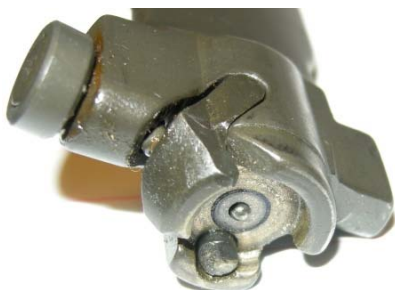
Bolt from M14 SSR -4360
Showing Modified Extractor

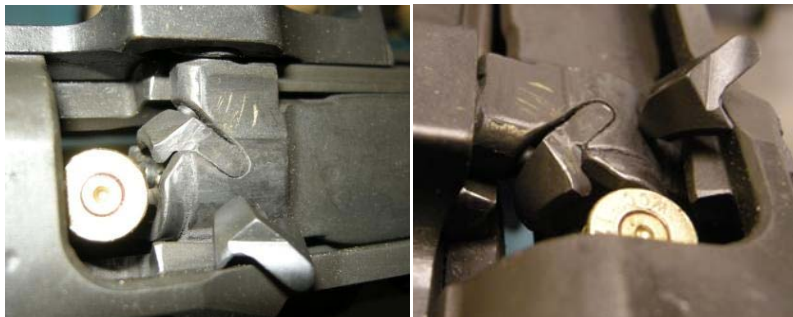
Modified Extractor in Bolt vs. New Condition

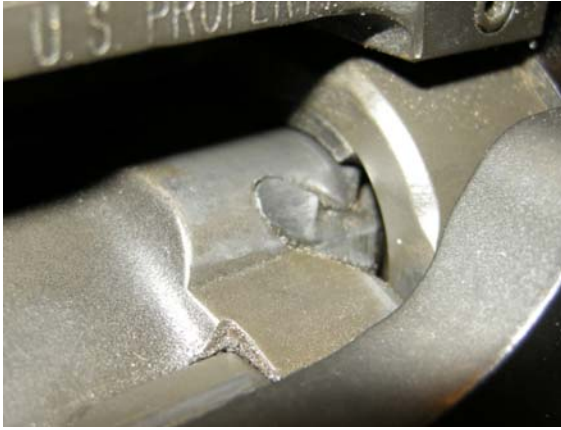
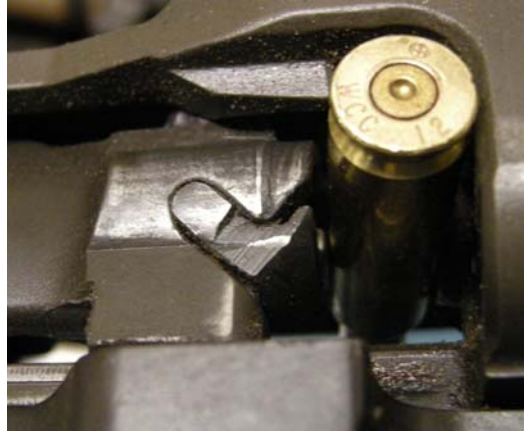
Modified Extractor in Old Black Stocked "M14 Sniper Kit" (SN – 0488)

Note: Barrel Shroud Cut Angle in first image is similar to that of the two MOD 2 rifles with issues

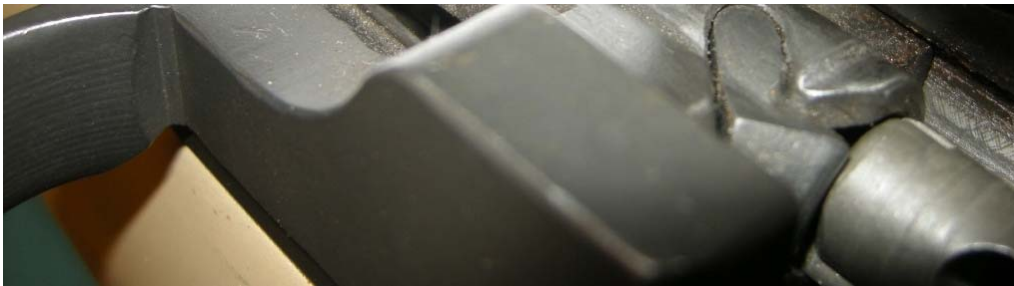
Recently Returned (for conversion to MOD 2) M14 SSR -7198 which has Modified Extractor
New unmodified extractor was installed and there were no issues (even with minimum length X spring/plunger)

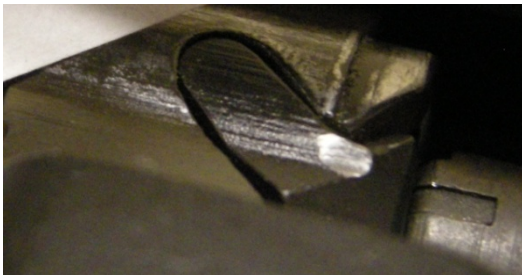
M14 SSR -1147 (older gray stocked with rear lug)
Extractor shows Barrel Contact – no Functional Issues

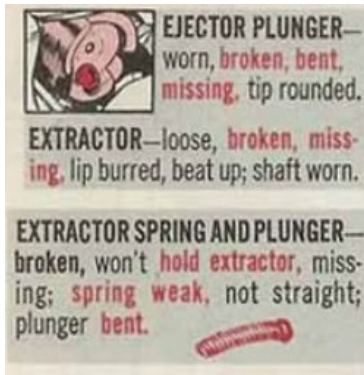
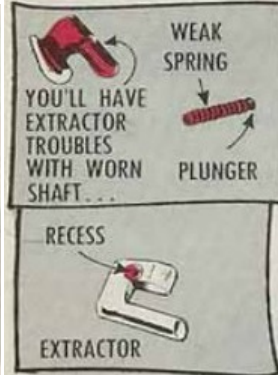
Does the extractor have a bad habit? Like jumping out of the bolt. That's usually caused by a worn extractor shaft and a weak spring and plunger.

Another thing about the extractor plunger... the round bottom head of the plunger wants to seat in the recess of the extractor. And if the plunger is bent, it'll foul up the movement of the spring. And you'll have extractor troubles. Something else... don't forget to keep a light coat of oil on the plunger.

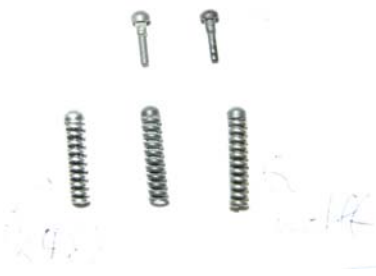
Spring Length and Plunger Head Thickness Tolerance Are Factors Impacting Extractor Retention (Wolff Aftermarket Spring on right)

Nominal Free Length of Extractor Spring per Drawing 6008886 is 0.480"
(a typical new spring measured 0.091" by itself and 0.566 inches as an assembly with the Plunger)

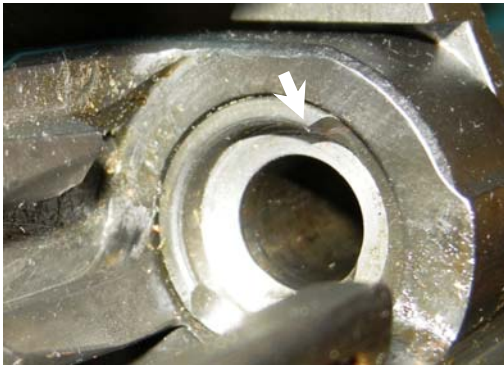
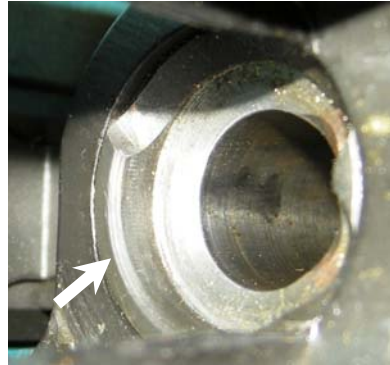
Standard Barrel Shroud Area (SAI) SN - 4360
(notice slight burr at top edge from minor extractor contact and large edge break / radius - see arrows)

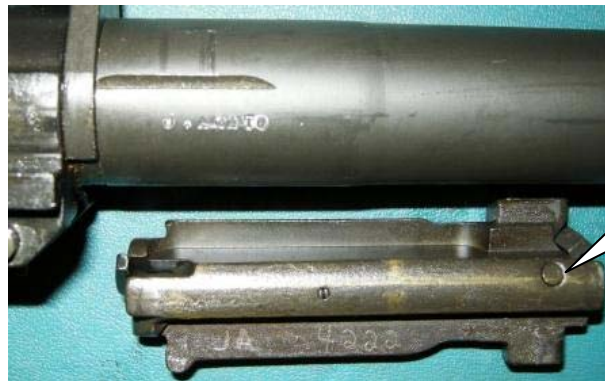
Notice Brass Color on
Extractor Indicating
Contact - Not Good

MOD 2 -4222 which Qualified after two changes of extractor, marking is from barrel installer/builder at Crane)
(most likely repeated firing peened interference and reduced risk of continued extractor kick out problems)

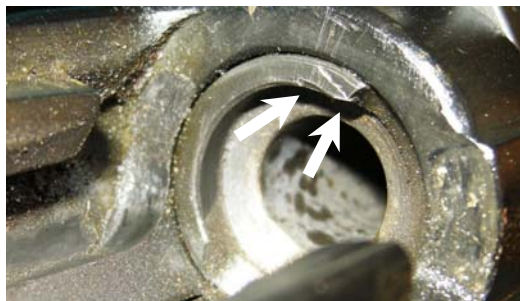
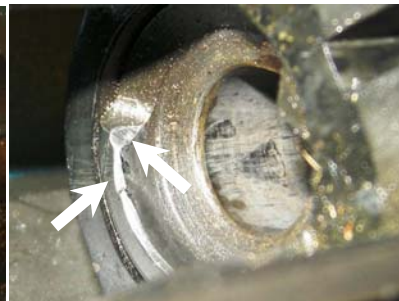
MOD 2 - SN - 4222 Barrel Shroud Area

Notice Severe Peening and Different Cut Configuration as well as less edge break/radius than standard SAI Barrel
This configuration leave more material for extractor interference both due to the different cut angle and from the minimal edge break (chamber along the rear inner edge of the shroud). Arrows indicate peening due to interference.

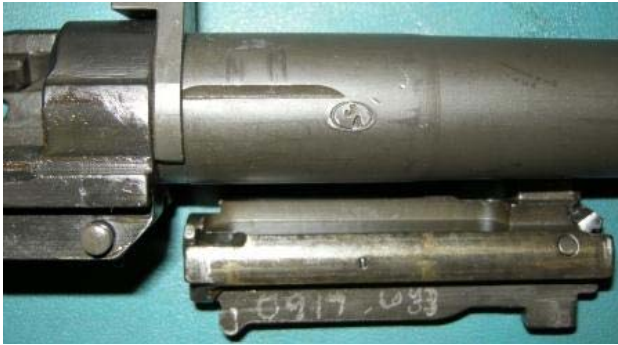
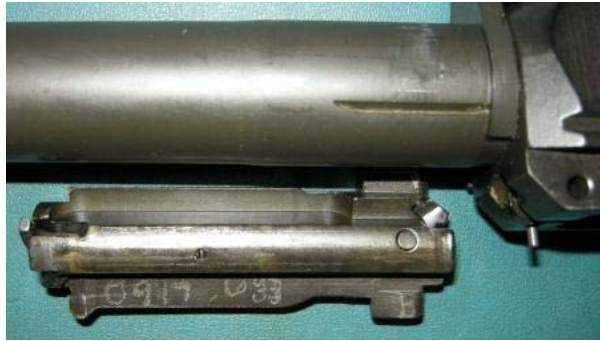
MOD 2 -0917 which had already been qualified – had extractor come out of proper engagement twice during additional function/accuracy testing and also caused a failure to chamber due to interference with the barrel shroud

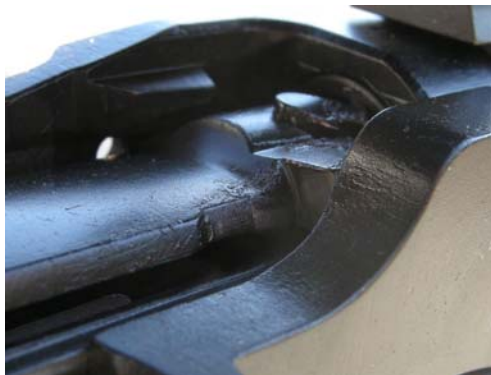
MOD 2 -0917 after first extractor event

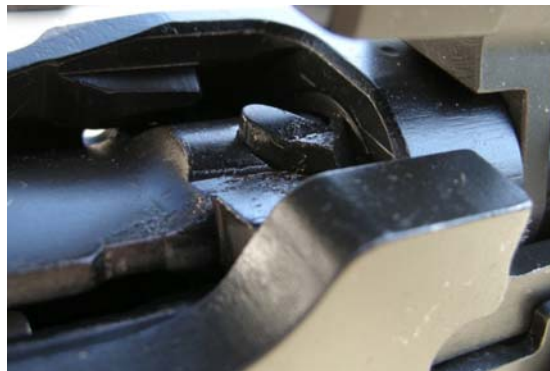
MOD 2 -0917 after second extractor event

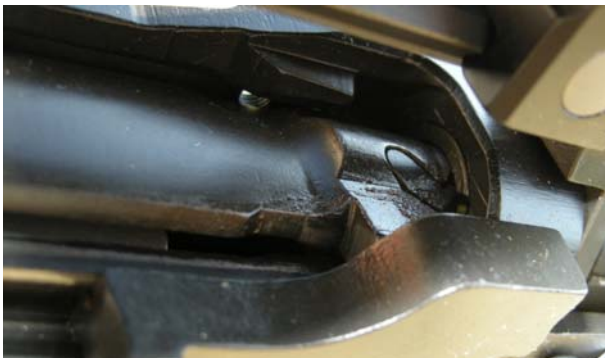
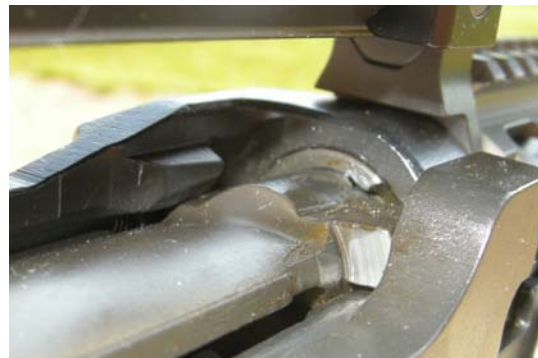
MOD 2 -0917 in between extractor events – Failure to Chamber due to extractor interference with Barrel Shroud (as case head is forcing extractor out/open to snap over rim it contacted the shroud binding the bolt before it could rotate into battery – extractor face against base/rim of cartridge)

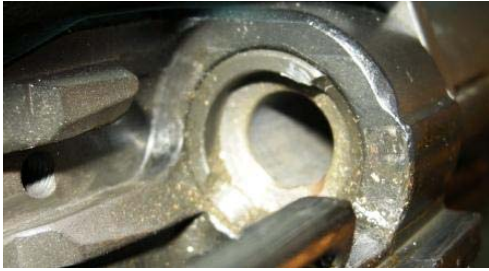
Chamber Barrel Shroud View of -0917
which has the same barrel config as -4222 above

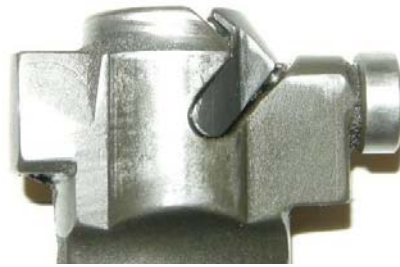
Typical M14 Bolt Head Configuration

Extractor that came disengaged twice (-0917) and also caused a stoppage without becoming disengaged
Its stem/ measured 0.695" (on the long side) and it
Did protrude below the bolt body. The detent dimple
Depth (as measured for comparative purposes – not true depth)
Was at 0.016" which is toward the shallower side of the range.
Arrows indicate barrel contact point
